CIA IMAGERY ANALYSIS DIVISION

CHI-MO/CHENG-YANG

MILITARY COMPLEX

CHINA

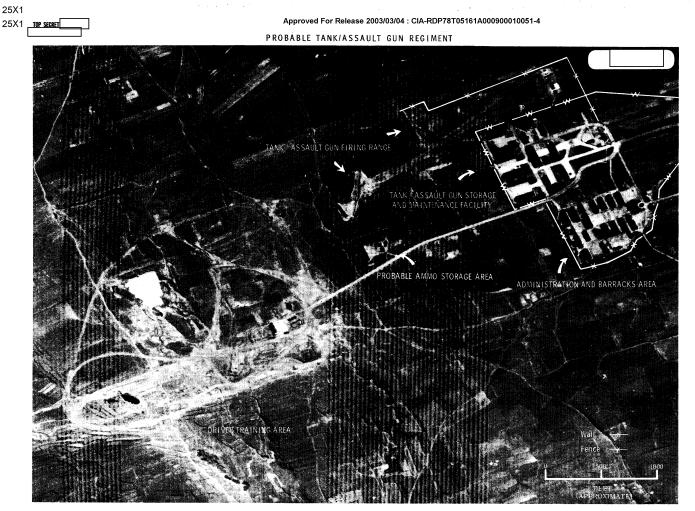
Figure 3 Approved For Release 2003/03/04 : CIA-RDP78T05161A000900010051-4

TOP SECRET	25X1
	CIA IMAGERY ANALYSIS DIVISION CIA/PIR-67244	
(1		
	PROBABLE TANK/ASSAULT GUN REGIMENT (36 17 50N-120 26 40E)	
NCTION	AL AREAS	25X1
I.	Tank/Assault Gun Storage and Maintenance Facility	
	2 Drive-through maintenance buildings	
	ll Vehicle storage buildings	
	3 Probable general support buildings 1 Probable storage building 4 Vehicle service ramps	
II.	Administration and Barracks Area	
	8 Barracks (single story)	·
	2 Possible barracks (single story) 1 Administration building 1 Probable auditorium 1 "H" shaped messhall 4 Support/storage buildings 1 Probable guardhouse 4 Miscellaneous small buildings	
III.	Barracks/Quarters Area (not shown on photograph)	
	4 Barracks/quarters (single story)	
	3 Support buildings 1 Support/storage building	
IV.	Probable Ammo Storage Area	
	5 Probable storage buildings 1 Support building	·
	- 1 ₁ -	
	TOP SECRET

V. Tracked Vehicle Driver Training Area.

Consists of a double closed-loop course. Two driver training obstacles are located on the course and I possible vehicle/equipment shed is located near the entrance of the course.

Tank/Assault Gun Firing Range.

This range consists of one combination subcaliber/main gun firing lane 1,250 feet long and one main gun firing lane 2,000 feet long.

The tank/assault gun storage and maintenance facility and the administation and barracks area are secured by a combination wall and fence around the entire installation. There are no apparent internal subdivisions or separately secured areas within this installation.

The barracks/quarters area is secured by a single fence and the tank/ assault gun firing range is partially secured by a single fence. No security measures are apparent at the probable ammo storage area or the driver training area.

Trackage and scarring in the driver training area, subcaliber/main gun firing range and the tank/assault gun storage and maintenance facility indicate a moderate degree of usage on all coverage. The barracks area appears well maintained and occupied. The only change noted in the installation was the addition, in of a probable moving target run and embankment for the main gun firing lane of the subcaliber/main gun range.

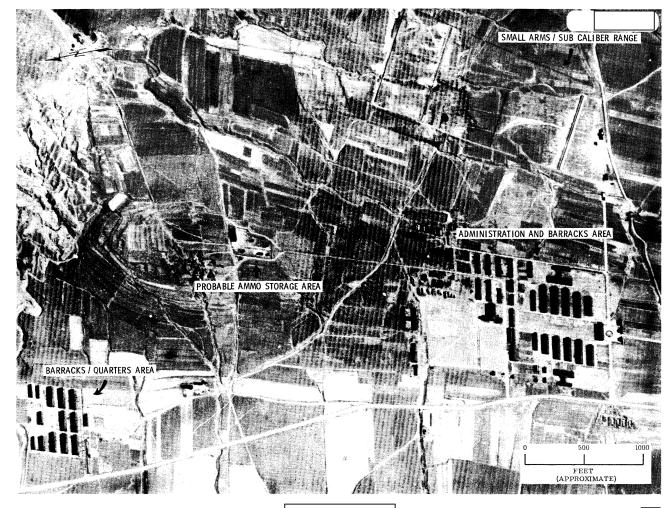
Figure 8

No vehicles or equipment observed on coverage of this area.

Approved For Release 2003/03/04: CIA-RDP78T05161A000900010051-4 PROBABLE INFANTRY REGIMENT (C) (PARTIAL COVERAGE)
